DEPARTMENT OF TRANSPORTATION**DIVISION OF ENGINEERING SERVICES**

Contract #: 04-0120F4Cty: SF/ALA Rte: 80 PM: 13.2/13.9File #: 1.28**WELDING INSPECTION REPORT****Resident Engineer:** Pursell, Gary**Address:** 333 Burma Road**City:** Oakland, CA 94607**Report No:** WIR-013937**Date Inspected:** 04-May-2010**Project Name:** SAS Superstructure**OSM Arrival Time:** 630**Prime Contractor:** American Bridge/Fluor Enterprises, a JV**OSM Departure Time:** 1500**Contractor:** American Bridge/Fluor Enterprises, a JV**Location:** Job Site**CWI Name:** Bernard Docena, Steve McConnell, CWI Present**Yes** **No****Inspected CWI report:** **Yes** **No** **N/A****Rod Oven in Use:** **Yes** **No** **N/A****Electrode to specification:** **Yes** **No** **N/A****Weld Procedures Followed:** **Yes** **No** **N/A****Qualified Welders:** **Yes** **No** **N/A****Verified Joint Fit-up:** **Yes** **No** **N/A****Approved Drawings:** **Yes** **No** **N/A****Approved WPS:** **Yes** **No** **N/A****Delayed / Cancelled:** **Yes** **No** **N/A****Bridge No:** 34-0006**Component:** SAS OBG 1W/2W-C, 3W/4W-A, 4E/5E**Summary of Items Observed:**

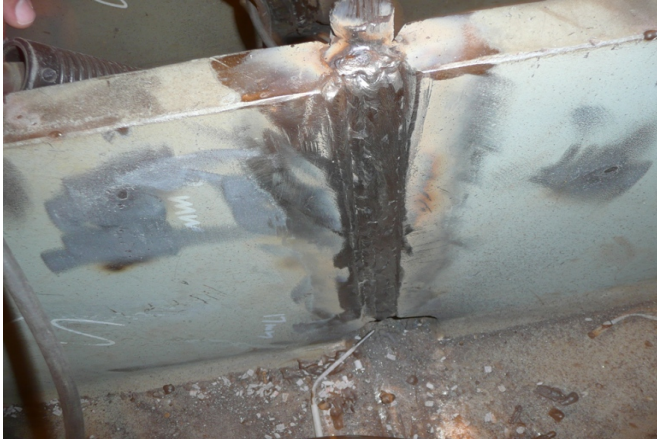
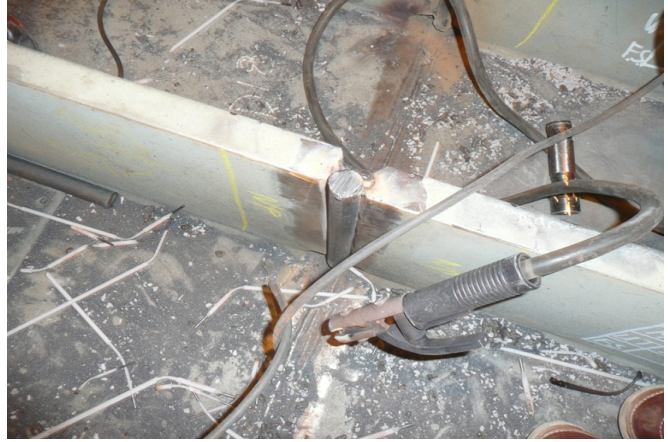
D/S-17 and 18

The QA Inspector randomly observed the ABF welder James Zhen performing shielded metal arc welding (SMAW) root/fill passes at the above identified stiffener plates (pictured below). The QA Inspector noted the ABF welder was utilizing 5/32" E7018 low hydrogen electrodes with 135 Amps. The QA Inspector noted the SMAW parameters appeared to be in general compliance with ABF-WPS-D1.5-1010. The SMAW was in process for the remainder of the QA Inspectors shift.
